**International Conference on Advanced Multidisciplinary  
Research and Innovation (ICAMRI-2025)**

**INVESTIGATION OF CORROSION BEHAVIOR IN FRICTION STIR  
WELDED DISSIMILAR MAGNESIUM ALLOYS AZ80A-T5 AND  
AZ91C-T6**

**Abstract**

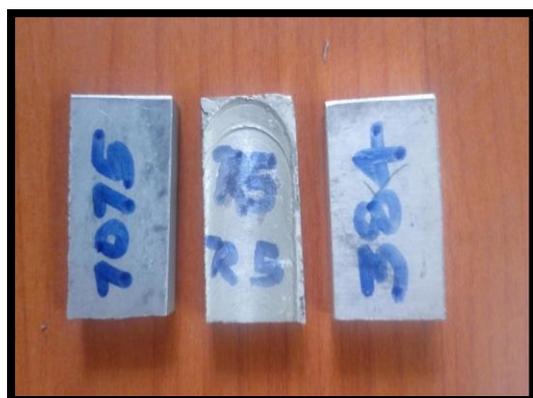
Figure 3.1 Specimens before corrosion test

The weight reduction being expressed in % also. This weight reduction is the Corrosion of that material. The specimens earlier than doing the corrosion take a look at are illustrated in Fig. 3.1 and the specimens after doing the corrosion check are illustrated in Fig.3.2

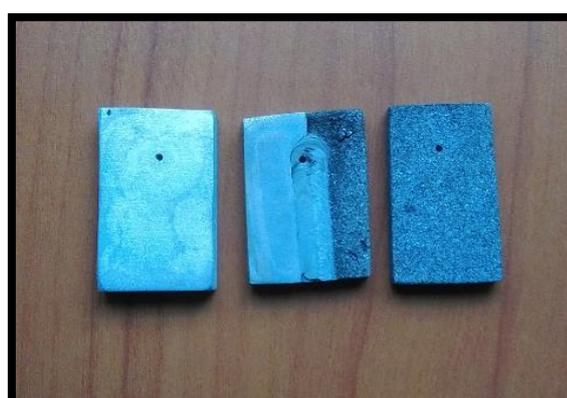
Figure 3.2 Shows the specimens after corrosion testing

In Fig3.2, the corrosion specimens display the lifestyles of pores over the floor. Because of the dearth of oxygen in a small pitting, corrosion is fashioned. In other phrases, a place with excess oxygen turns into cathodic and a place with low oxygen becomes anodic. Because diffusion of ions is limited, the corrosion permeates the steel, in addition generating localized oxygen deprivation (Galvele et al., 2005). The corrosion takes a look at consequences of the base substances of A384.Zero-T6, AZ80A - T5, and the Run #5 which changed into recorded to be minimal americaand the equal is proven in table 3.1.

The burden losses of the determine fabric AZ80A - T5, AZ91C – T6 and Run #5 are calculated and tabulated in table 3.1. This turned into analysed. On this evaluation, the corrosion is less in AZ80A - T5 wrought magnesium alloy, due to its high tensile power. Whereas in AZ91C – T6 forged magnesium base fabric, the corrosion values are in-among the FSW weld of Run #5 and the discern cloth of AZ91C – T6 magnesium alloy. Inside the examined specimens, the existence of pores over the floor changed into without problems recognized by using the naked eye that is shown in Fig 3.2. The Run #5 has extra corrosion in comparison to the two determine materials.
